# **INDOOR AIR QUALITY ASSESSMENT**

**Nissitissit Middle School  
33 Chace Avenue  
Pepperell, Massachusetts**

Prepared by:  
Massachusetts Department of Public Health  
Bureau of Environmental Health Assessment  
June 2003

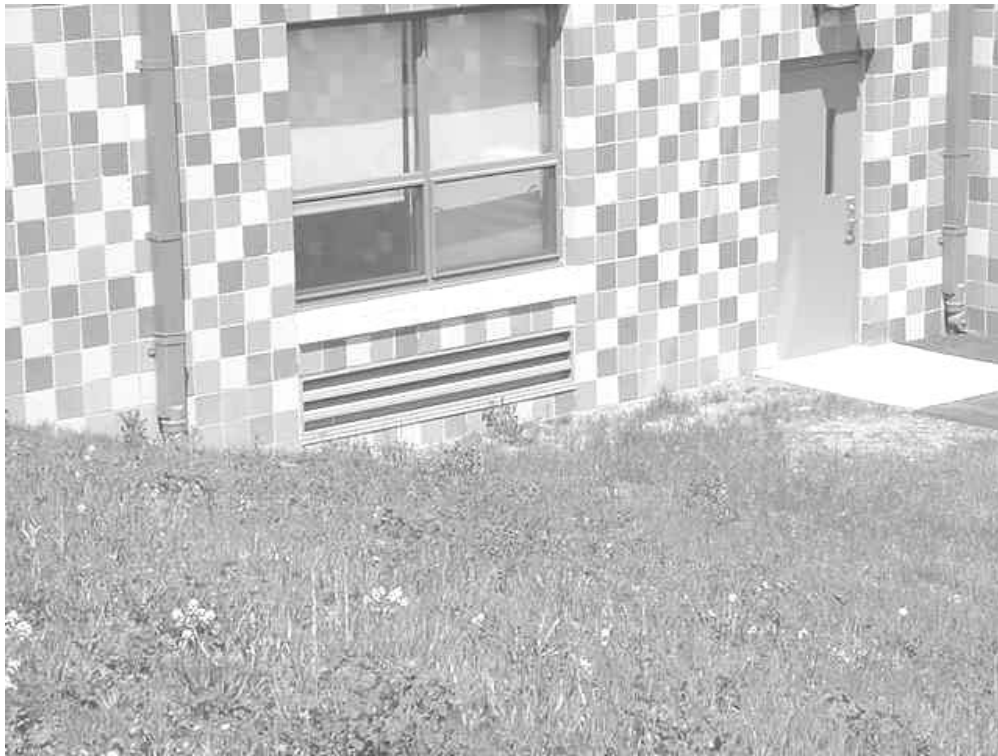
**Picture 1**

Univents draw air from outdoors through a fresh air intake located on the exterior walls of the building (see Picture 1) and return air through an air intake located at the base of each unit (see [Figure 1](#)). Fresh air and return air are mixed, filtered, heated and provided to classrooms through a fresh air diffuser located in the top of the unit.

**Univent Fresh Air Intake**

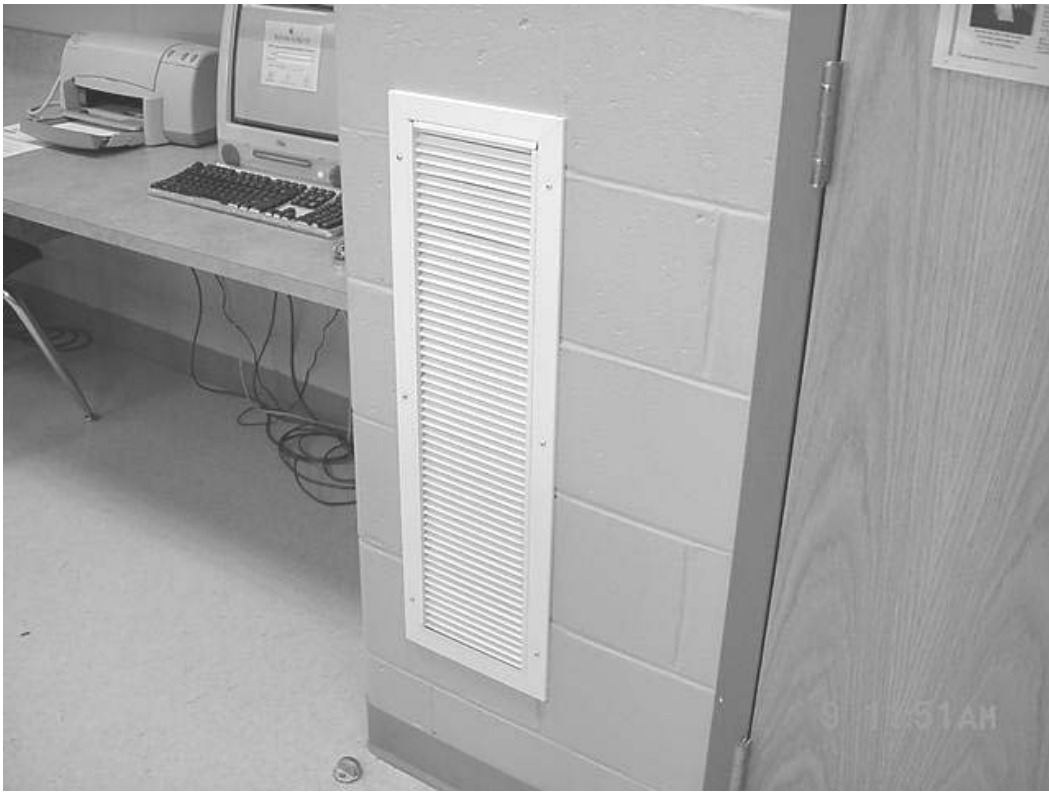
**Picture 2**

The mechanical exhaust ventilation system consists of ceiling and wall-mounted exhaust vents (see Picture 2). These vents were operating throughout the building, with the exception of classroom 211. Little or no draw of air was detected in this classroom (see Tables), which can indicate that either the exhaust ventilation was turned off or that the rooftop motor was not functioning. Without removal by the exhaust ventilation, normally occurring environmental pollutants can build up and lead to indoor air complaints.

**Wall-Mounted Exhaust Vent**

3. Examine rooftop exhaust motors detailed in the ventilation section of this report for proper function. Repair/replace belts and parts as necessary.
4. Continue working with current HVAC contractor to troubleshoot problems and develop a preventive maintenance plan.

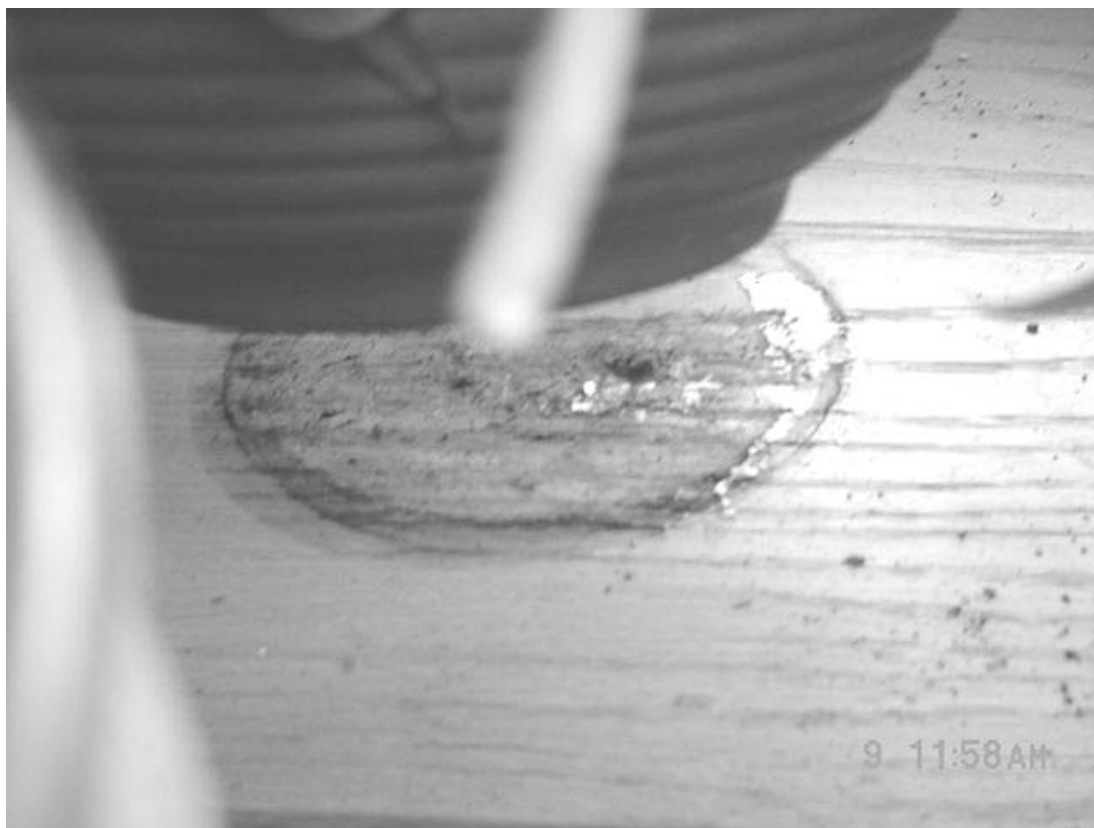
**Picture 3**

Several classrooms had a number of plants. Moistened plant soil and drip pans can be a source of mold growth. Plants should be equipped with drip pans; the lack of drip pans can lead to water pooling and mold growth on windowsills (see Picture 3). Plants are also a source of pollen. Plants in several classrooms were noted near univent air diffusers (see Picture 4). Plants should be located away from the air stream of ventilation sources to prevent the aerosolization of mold, pollen or particulate matter throughout the classroom.

**Water Pooling/Staining on Wooden Windowsill in Classroom**

10. Clean and maintain aquariums prevent bacterial/mold growth and/or odors.
11. Remove plants from the air stream of univents. Ensure all plants are equipped with drip pans. Examine drip pans periodically for mold growth and disinfect with an appropriate antimicrobial where necessary.

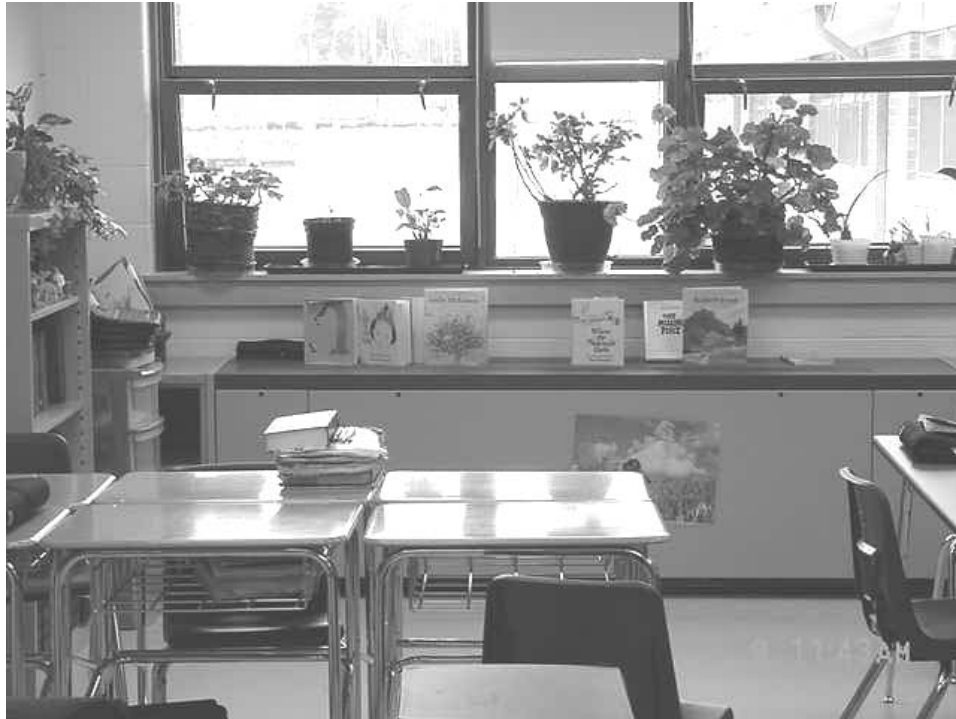
**Picture 4**

A univent was found deactivated in classroom 114. Mr. Kennison believed this univent was deactivated the week (April vacation) prior to the BEHA assessment so it could be cleaned and have the filters changed. The univent was reactivated by Mr. Kennison and it appeared to be operating correctly. Obstructions to airflow, such as books, papers, and desks were seen in a number of classrooms, as well as items in front of univent return vents. In order for univents to provide fresh air as designed, they must be unblocked and remain free of obstructions.

**Plants Over Univent Air Diffusers/Items on Univent**

5. Remove all obstructions from univent air diffusers and return vents to facilitate airflow.
6. Continue working with HVAC firm to balance the mechanical ventilation system. Consider having the ventilation system balanced by an HVAC engineer every five years (SMACNA, 1994).

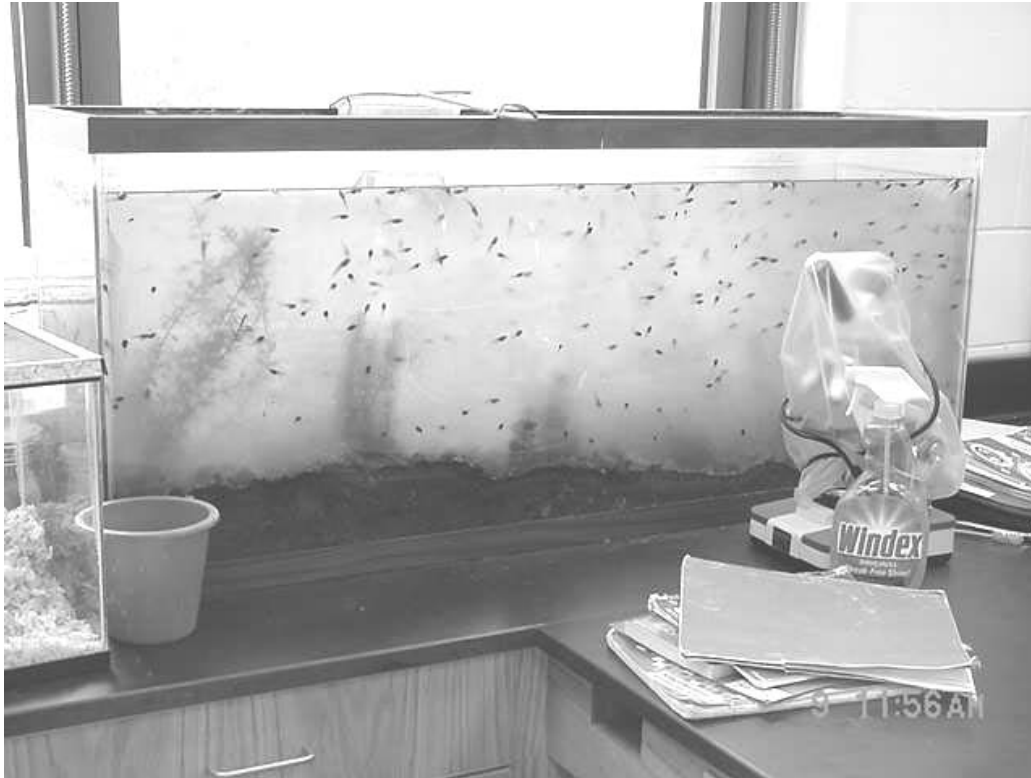
**Picture 5**

Several rooms contained aquariums with standing water (see Picture 5). Aquariums should be properly maintained to prevent bacterial growth, mold growth and nuisance odors.

**Aquarium With Standing Water**

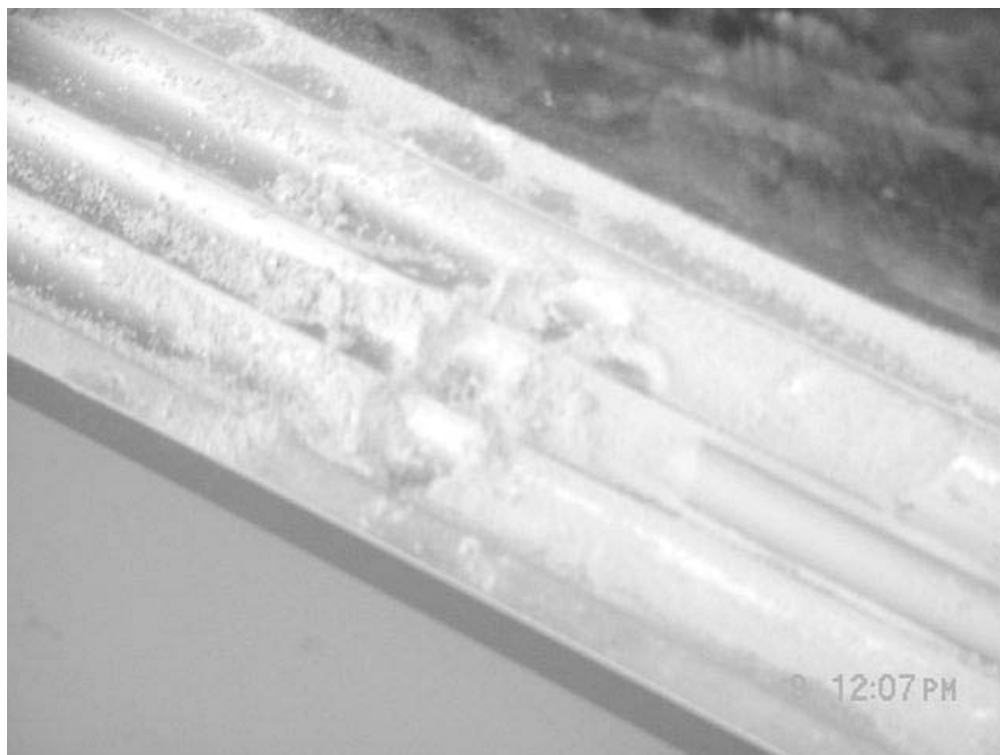
**Picture 6**

A number of other conditions that can potentially affect indoor air quality were also observed. Accumulated chalk dust was noted in several classrooms (see Picture 6).

Chalk dust is a fine particulate, which can be easily aerosolized and is an eye and respiratory irritant. Several rooms had various objects hung from the ceiling tile system (see Picture 7). Building occupants should refrain from hanging objects to prevent damage to the ceiling tile system. Damaged/dislodged ceiling tiles can provide a pathway for the movement of drafts, dusts and particulate matter between rooms and floors.

**Accumulated Chalk Dust in Classroom**

12. Clean chalkboards and trays regularly to avoid the build-up of excessive chalk dust.
13. Refrain from hanging objects from ceiling tile system.
14. Ensure that outside contractors check in with school maintenance personnel before conducting repairs/activities that create odors, dusts fumes etc.

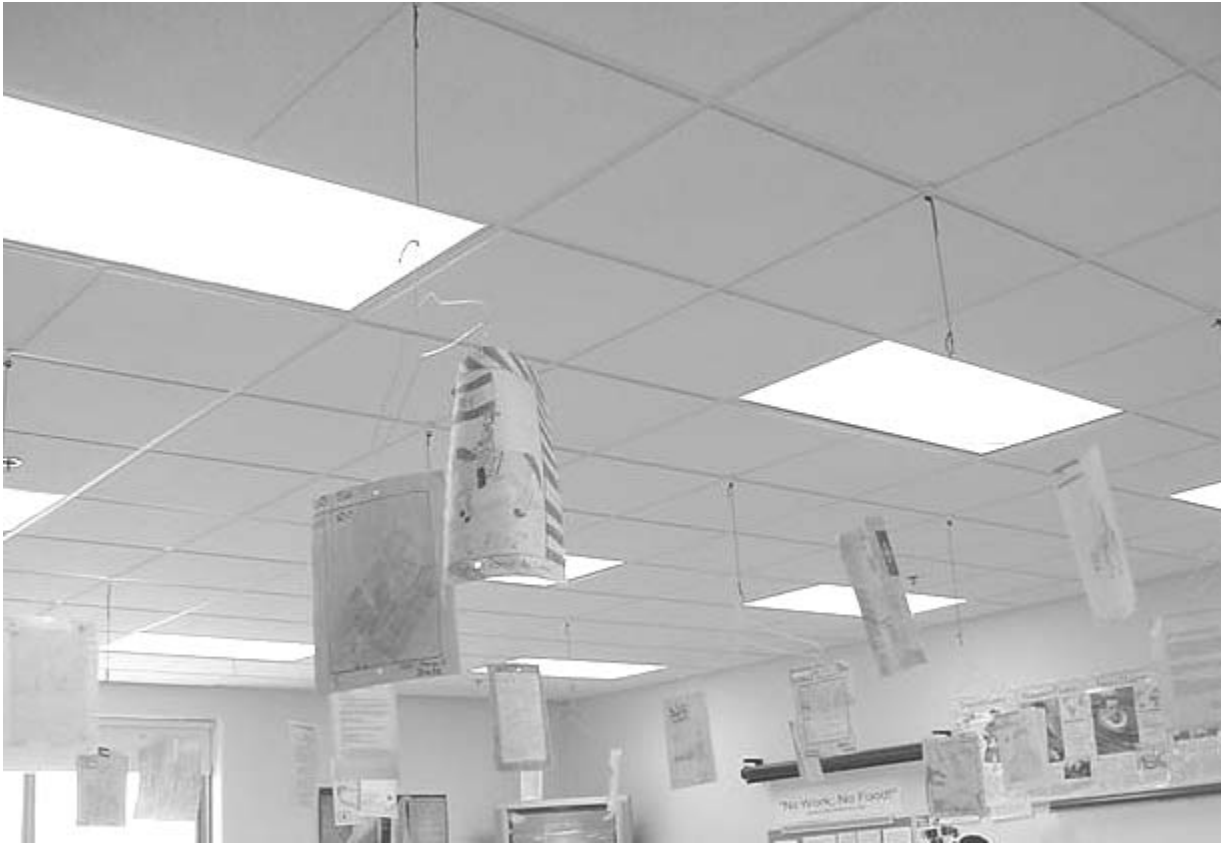
**Picture 7**

**Objects Hanging from Ceiling Tiles in Classroom**

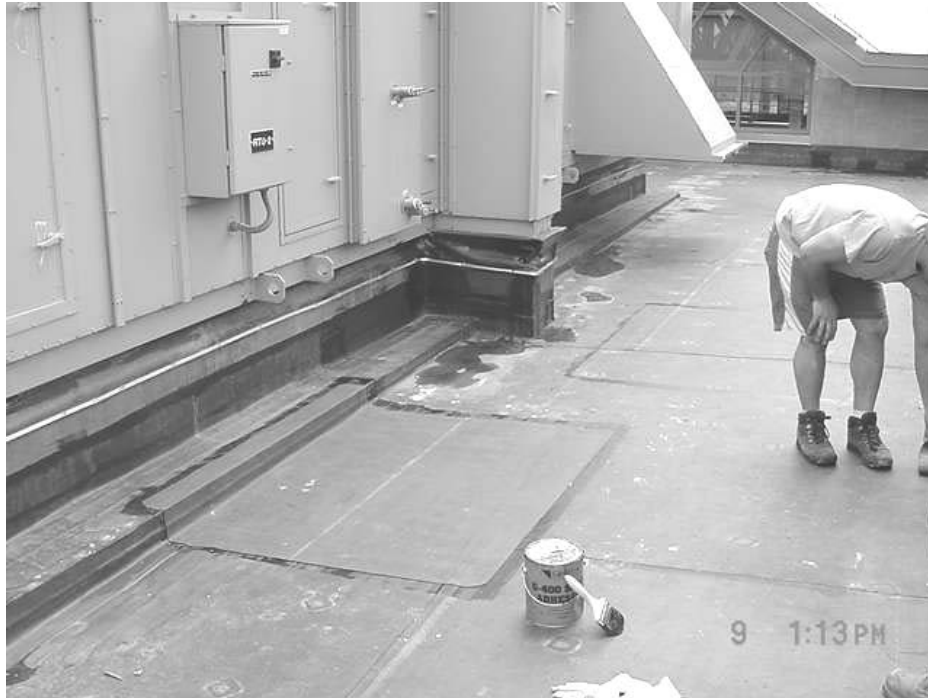
**Picture 8**

As discussed in the Ventilation section of this report during the assessment BEHA staff, were in agreement with Pepperell Maintenance personnel that the rooftop AHU servicing the main office area be temporarily deactivated. Occupants in the main office reported chemical odors during the assessment. Measurable readings of TVOCs over background were recorded by BEHA staff in the main office and adjacent areas (see Tables). According to school maintenance officials a work crew was scheduled to conduct repairs on the rubber membrane roof. BEHA staff accompanied school maintenance officials to the roof and found the work being conducted directly below the air intake for the AHU that supplies the main office (see Picture 8). After discussion with BEHA staff and Mr. Wirtanen, school Maintenance staff immediately deactivated the unit to prevent entrainment of odors. As discussed, VOCs can be irritating to the eyes, nose and throat. Several minutes after the system was deactivated the main office was revisited. Occupants reported that the odors had ceased. Due to the rapid dissipation of

the product, any acute health effects associated with short-term exposure that may have occurred (e.g. eye, respiratory irritation), would be unlikely to result in any long term health concerns.

**Air intake**

**Roof Repair Using VOC-containing Mastic**

2. Use local exhaust ventilation and isolation techniques to control for renovation pollutants. Precautions should be taken to avoid the *re-entrainment* of these materials into the building’s HVAC system. The design of each system must be assessed to determine how it may be impacted by renovation activities. Specific HVAC protection requirements pertain to the return, central filtration and supply components of the ventilation system. This may entail shutting down systems (when possible) during periods of heavy construction and demolition, ensuring systems are isolated from contaminated environments, sealing ventilation openings with plastic and utilizing filters with a higher dust spot efficiency where needed (SMACNA, 1995).
